# BELZONA 7211 DEEP POUR GROUT FOR TANK BASE

ID: 8581

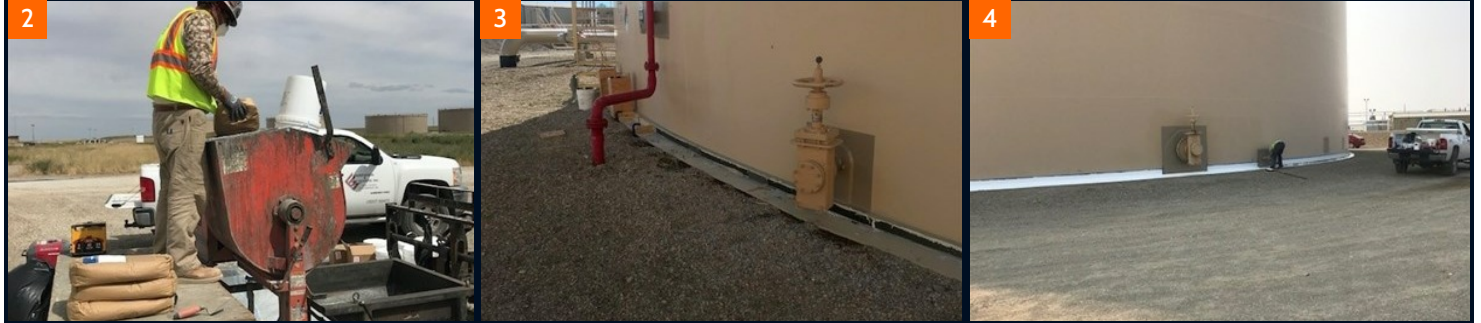
1) Sections of failing Cementous grout easily removed in sections.

2) Belzona 7211 mixed and transported to pour site where form work and head boxes were installed. Belzona 5811 was used in sections less than 2" deep.

3) View of a section being poured next to previously poured section. Work was done in sections to prevent excessive loads without a base.

4) Belzona 5111 being applied to provide an UV resistant coating over grout.
