# BELZONA REBUILDS NOT ONE BUT TWO 250-YEAR-OLD STONE STAIRCASES

ID: 8585

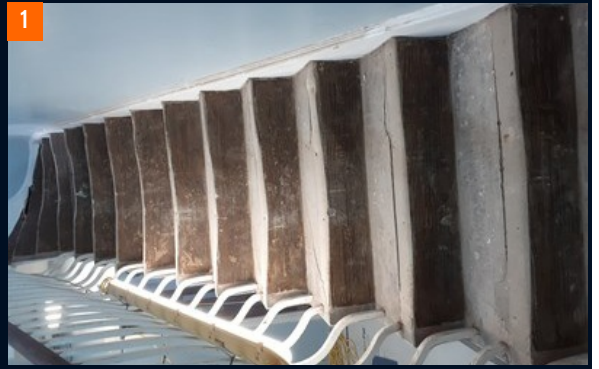
The first staircase was badly worn from 250 years of use, making them a health and safety concern. Some steps had worn up to 40mm in the centre. The second main feature curved staircase had previous historic repairs that had failed again also making this feature staircase a health and safety concern. Both staircases were built in stone with wrought iron balustrades.

1. Worn stone steps of upper staircase prior to application showing wear up to 40mm in the centre of the step.

The steps were worn smooth, therefore, the surfaces needed to be roughened with a grinder. Wooden shuttering, coated in Belzona 9411 Release Agent was laser aligned and installed to ensure the correct level to each step. Each step was then coated with Belzona 4911 TX Conditioner prior to the application of Belzona 4131 Magma Screed. The main feature steps had to be reinforced with perforated mesh as there was a 30mm overhang to be incorporated into the repair.

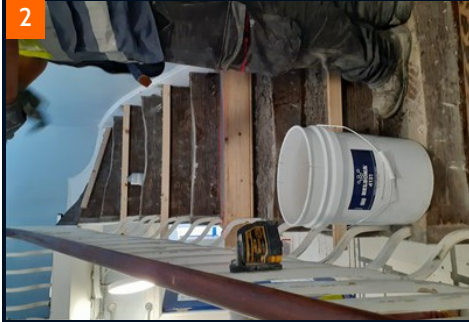
2. Wooden shuttering in place steps conditioned and Belzona 4131 being applied.

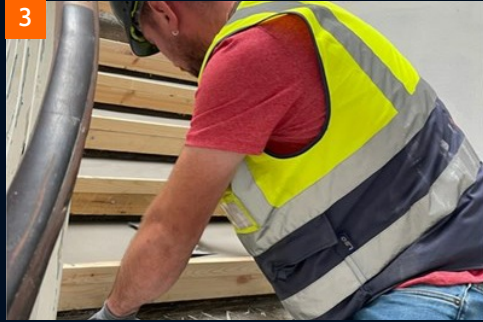
3 The main staircase during application, showing the perforated mesh reinforcing sheet over the failed historic repair.

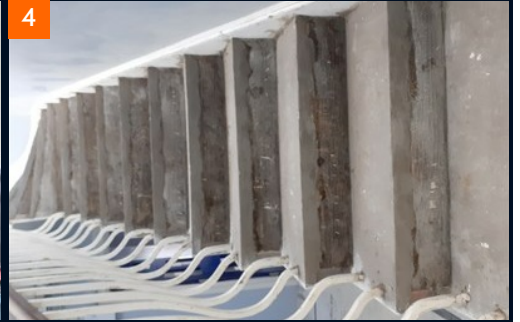
4. Upper staircase application completed awaiting covering and grip nosings.

The steps were completed during the evening once other trades had finished for the day. This allowed for the Belzona 4131 Magma Screed to cure overnight allowing the steps to be used the following morning. Using Belzona allowed for full access during normal working hours, therefore ensuring the project was not delayed and finished on time.
