# BELZONA REPAIRS CAVITATION DAMAGE TO THE BULK CARRIER PROPELLER BLADES

ID: 8587

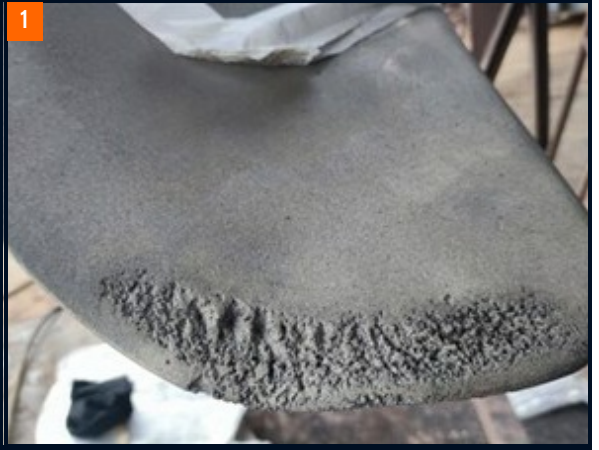
Propellers on bulk carrier had severe cavitation damage on all four blades of propellers.

1. Surface preparation with sandblasting
2. Rebuilding metal loss with Belzona 1311
3. Cavitation prevention with Belzona 1321
4. Complete application

The application was carried out in accordance with Belzona Know-How System Leaflet SOS-1 and SOS-2.
