# BELZONA SUPERWRAP II FOR PITTED PIPING

ID: 8592

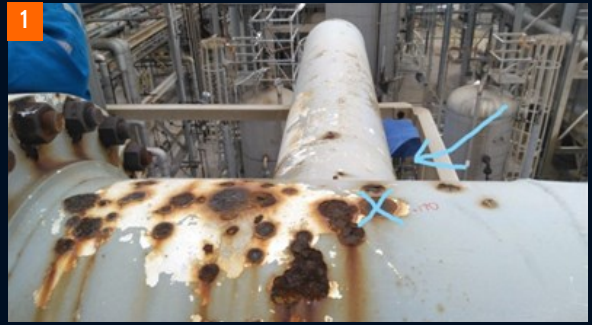
Localized corrosion in the form of deep pits was on the verge of holing through.

Piping near a cooling tower was severely corroded due to cooling tower mist.

1. Defective Asset
2. Graphic for Design Package
- 3-4. Final Repair

Wire brush preparation was performed around critical defects. Belzona 1212 was then used to cover critical defects. Once Belzona 1212 became machinable, a MBX was used to create an SSPC-SP 11 surface cleanliness level on the surrounding good metal. Belzona 1161 was used to smooth out the repair area and SuperWrap II was applied in a patch form as a 6 layer system.
