# BELZONA SEALS UNSANITARY LEAKING FLOOR DRAIN IN FOOD PLANT

ID: 860

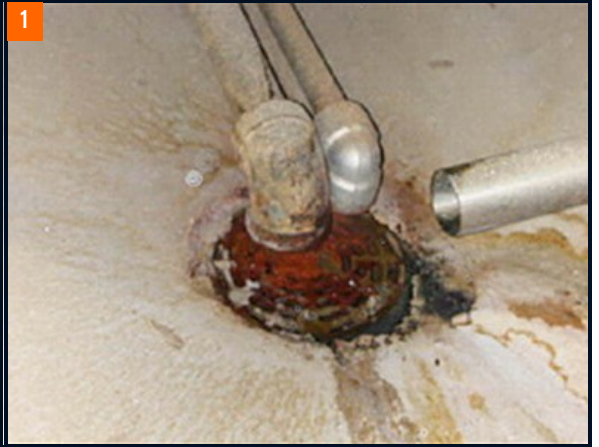
Leak around drain allowed waste product into the sanitary production packaging floor below.

1. Unsanitary, leaking drain
2. Surface prepared
3. Belzona 4111 installed
4. Drain cover installed
