# BELZONA OVERHAULS A PUMP IN A WASTE INCINERATION PLANT

ID: 8620

Duchting Pumpen MC 300-500 after many years of operation was damaged by numerous body cracks and other damage.

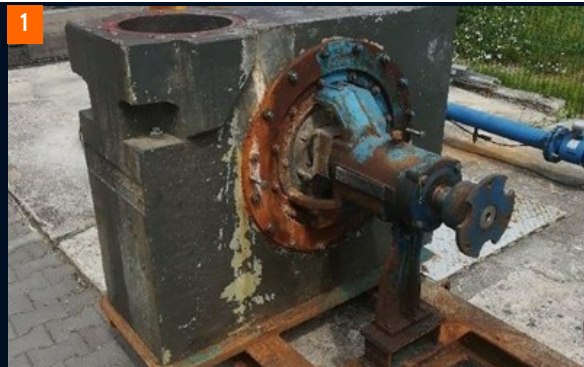
- 1 - Damaged Pump
- 2 - Cracked Casing to be repaired with Belzona 1111
- 3 - Internal Lining coated Belzona 1381
- 4 - Completed Application
