# INDUSTRIAL FLOOR COATED WITH BELZONA

ID: 8621

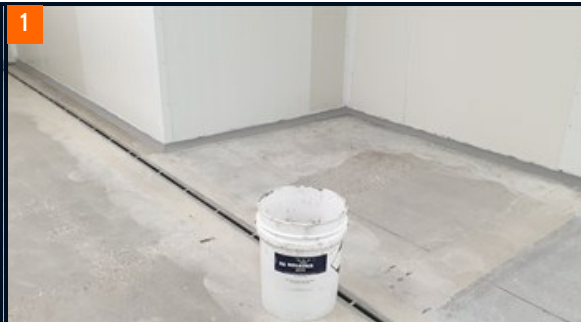
Maintaining the required hygiene and cleanliness of the production hall. Unevenness of the floor surface and damage to the pedestals arose as a result of intensive vehicular traffic of internal transport.

Image 1 - Damaged floor to be repaired with Belzona 4111

Replenishment of cavities, repair of the floor surface, making a new smooth washable surface. Low-cost technology compared to traditional methods, applied in accordance with Belzona system leaflet FPA-3.

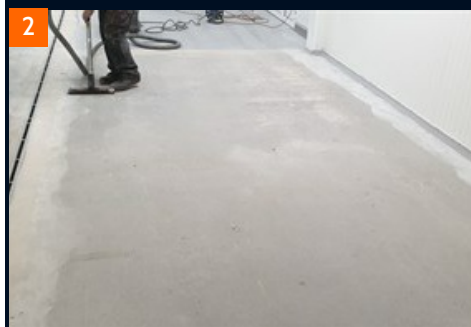
Image 2 - Vacuuming up any loose debris and dust.

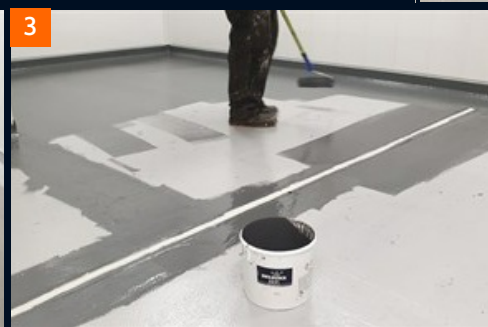
Image 3 - Roller Brush Application of Belzona 5231

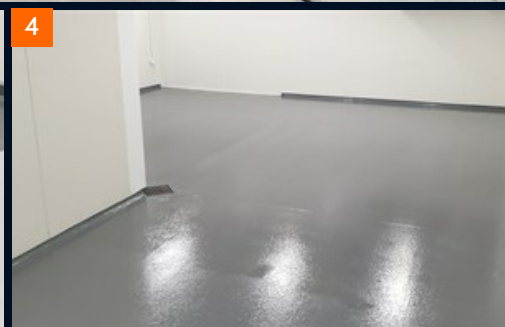
Image 4 - Completed Application
