# BELZONA PROTECTS CLARIFIER TRACK

ID: 8622

The track on an effluent clarifier had become damaged over time, so a solution was needed to rectify this.

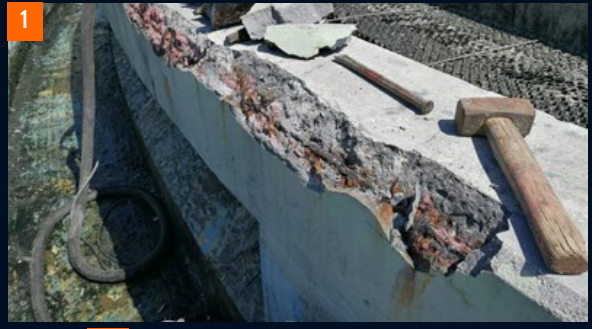
1. Removal of spooled and damaged concrete
2. Removal of spooled and damaged concrete
3. Conditioning of the substrate
4. Completed application

Any loose material was removed and shuttering installed to the required height. The substrate was conditioned with Belzona 4911 and rebuilt with Belzona 4111.
