# BELZONA PREVENTS WATER DAMAGE ON A HOSPITAL ROOF

ID: 8629

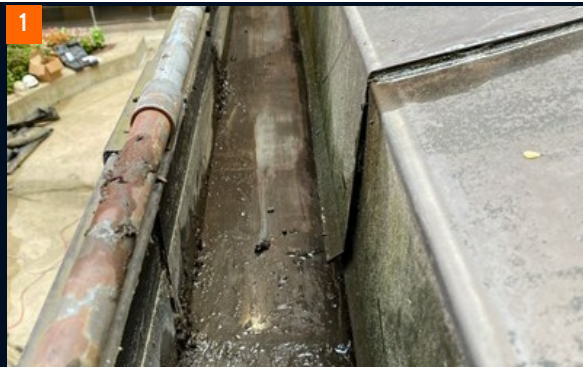
Rainwater was penetrating into the building

Rainwater was filling the gutters and entering behind the flashing into the building.

1. Original condition of the guttering
2. Application in progress
3. Completed application
