# BELZONA RESEALS AROUND ROOFTOP A/C UNITS

ID: 863

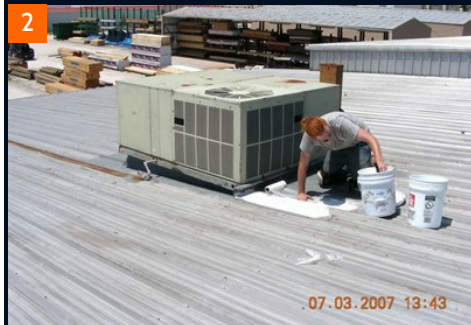
Over zealous painter overcoated Belzona repair with an aluminum paint that caused the Membrane to crack leading to roof leaks

1. Start of the application
2. Sheet being incorporated in Belzona 3111 coating
3. Application continuing
4. All sides waterproofed

Application was carried out in accordance with Belzona Know-How System Leaflet RPA-8
