# BELZONA PROTECTS A LOADER

ID: 8630

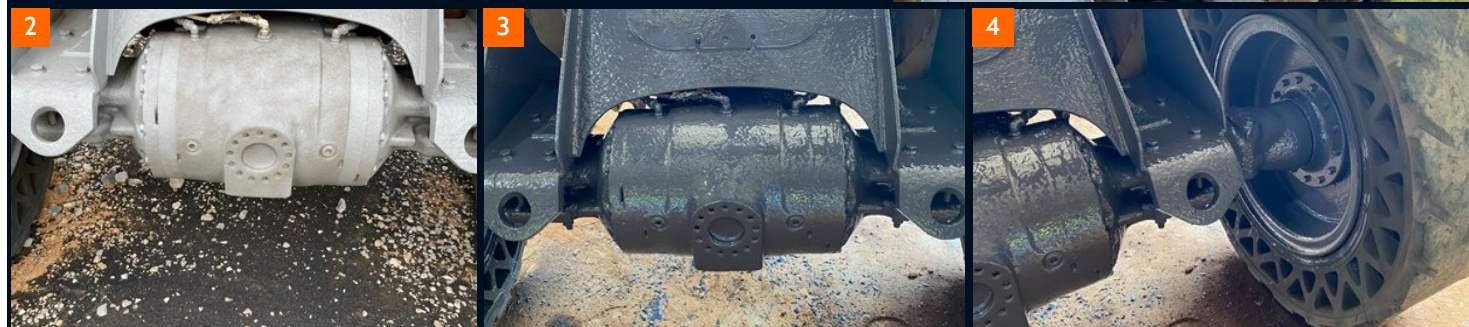
## PHOTOS

The metal on the front of the loader was being subjected to chemical attack due to the battery acid. A coating was required which would be able to protect it from further chemical attack due to exposure to the battery acids.

battery acid spillages onto the loader had caused the previous coating to fail, leaving the metal below open to chemical attack.

1. Grit blasted area
2. Grit blasted area
3. Coating applied
4. Coating applied

The areas that required protection were grit blasted back to white metal. Belzona 4311 was then mixed and applied.
