# BELZONA PROTECTS PUMPS FOR WATER TREATMENT PLANT

ID: 8631

Water treatment pumps required protection

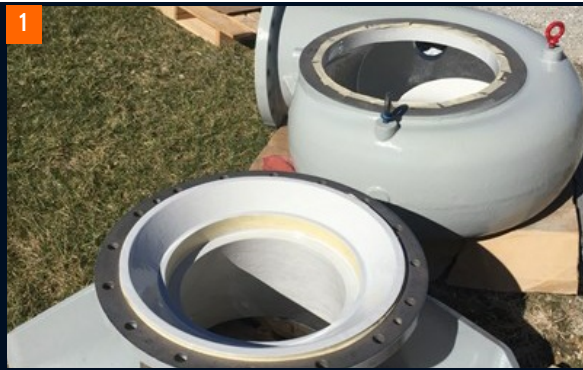
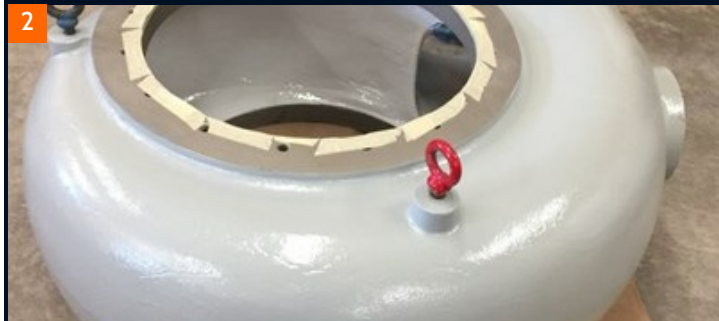
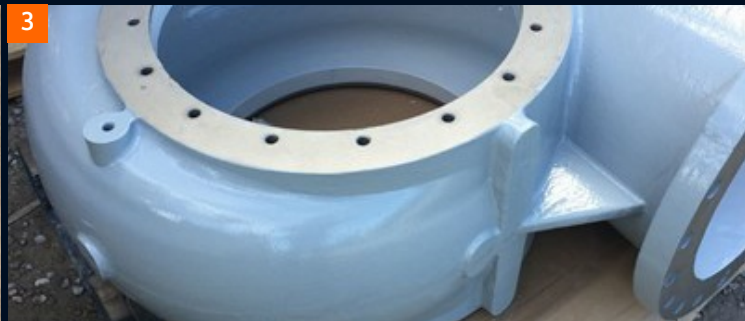
Pump linings suffer from erosion and corrosion over time due to exposure to the process stream. A lining resistant to erosion was required

1-3. Completed application

Belzona 1331 was applied to the grit-blasted internals of the pumps
