# BELZONA SOLVES BALANCE PROBLEM ON IMPELLER

ID: 864

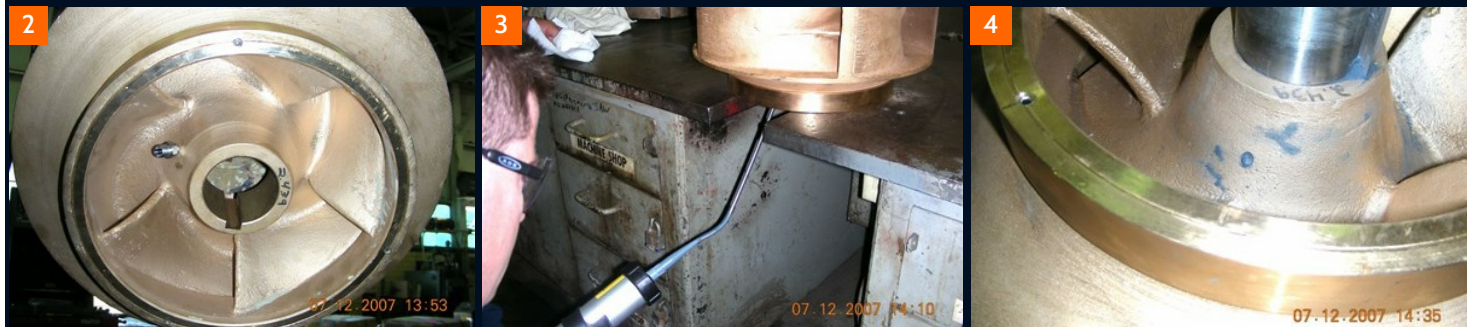
## PHOTOS

Liquid slowly entered the void during operation causing an imbalance and vibration.

Impeller did not have a solid center bore. Instead, it had a boss fit on both sides with a 60 cubic inch void in the center.

1. General view of the impeller
2. Injection port fitted
3. Injection underway
4. Vent port filled after injection completed

Belzona® 1321 was injected into the void, filling it completely. Application followed Belzona Know-How System Leaflet GSS-9
