# SLIPPERY METAL? BELZONA IT.

ID: 8653

Metal diamond plate underground vault cover.

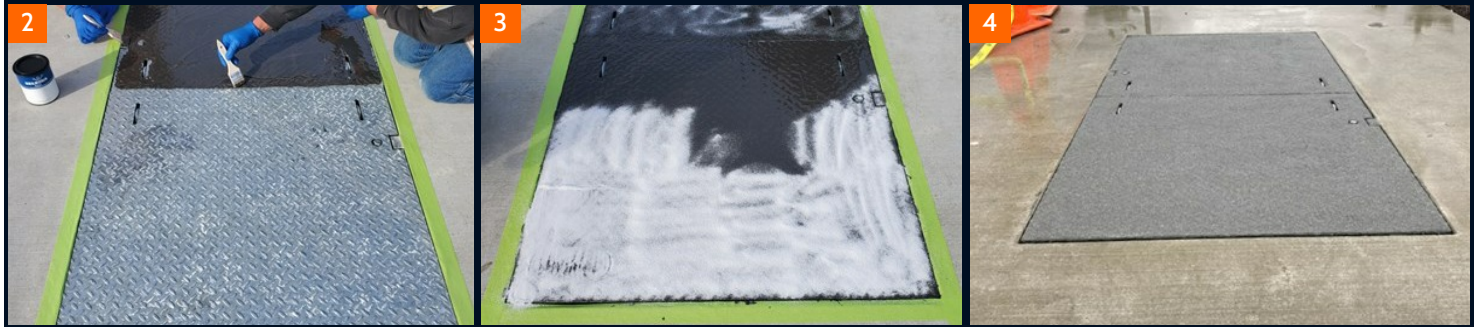
## PHOTOS

Even though the vault cover was diamond plate, it was found to be slippery when wet. At the location of this vault, it rains 150 days per year on average, resulting in a slippery surface in the middle of a sidewalk for almost half of the year.

1. Grinding the surface of the vault cover.
2. Applying the Belzona 1821.
3. Applying the Belzona 9221.
4. Application complete.

A grinder was used to roughen the surface, and then washed down with solvent to clean off any contamination. The Belzona 1821 was mixed and applied by brush to ensure maximum adhesion, and finished by using an applicator to spread it out evenly. The Belzona 9221 aggregate was then sprinkled to refusal and packed into place using a wooden block. After 4 hours, the excess aggregate was vacuumed up leaving a clean non-slip finish.
