# SUMP REPAIR WITH BELZONA AT YEAST PLANT

ID: 866

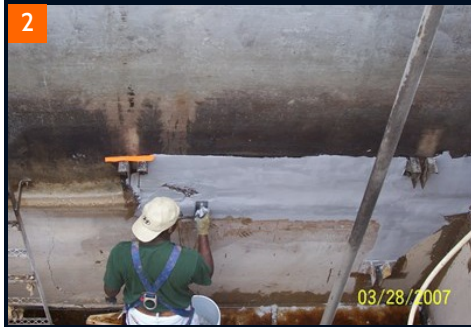
After years of running 24 hours a day, 7 days a week the sump had erosion and corrosion from chemical attack at the water level.

1. Sump prior to repair
2. Sump under repair
3. Sump after repair
4. Sump after repair
