# BELZONA SUPERWRAP II PATCH REPAIRS LEAKING VESSEL WELDS

ID: 8666

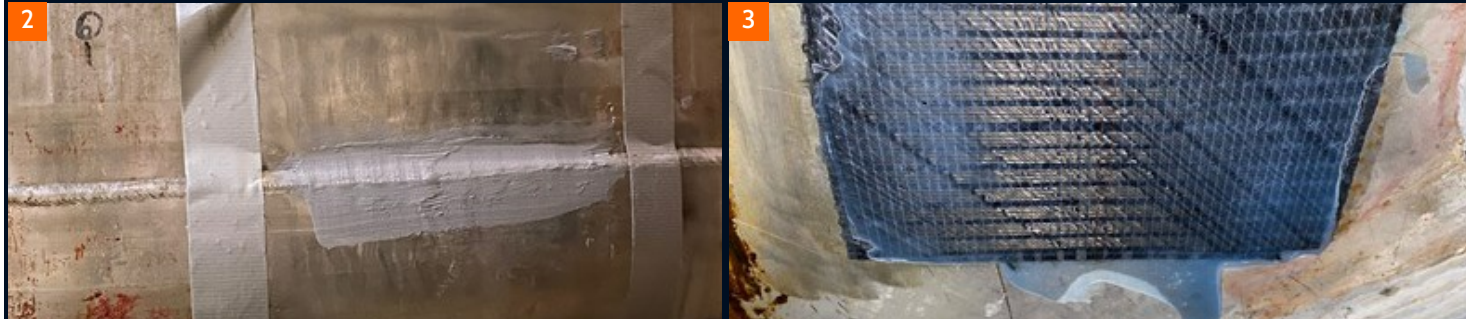
Stainless steel vessels had developed pinhole leaks around welds. A cold applied & fast back to service repair was required to seal these leaks during a shutdown.

- 1 - Surface preparation carried out
- 2 - Belzona 1111 applied to fair the surface
- 3 - Wrap system applied & consolidated using formers & straps to compress

The areas were first prepared using an MBX Bristle Blaster. Belzona 1111 Supermetal was applied to fair any defects. A four layer patch system was created using Belzona 1981 SuperWrap II resin, and Belzona 9381 reinforcing sheet. This application was completed in accordance with Belzona system leaflet TCC-1.
