# BELZONA REPAIRS BIODIESEL COLUMN

ID: 867

Biodiesel Column

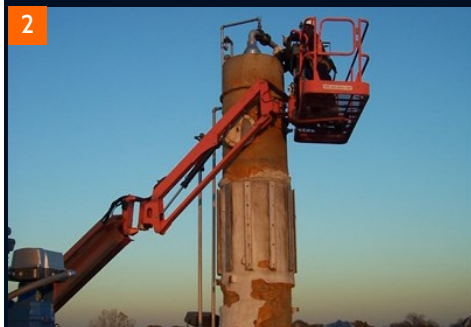
Due to stress on a flange there was a crack at the weld causing Biodiesel to leak. This was 130 feet above the ground.

1. The column to be repaired
2. Column under repair
3. Repaired area on column
4. Repaired area close-up

Application was carried out in accordance with Belzona Know-How System Leaflet CEP-3 & 6.
