# BELZONA REPAIRS MULTI-STAGE PUMP

ID: 8683

A multi-stage pump operating in a power station was badly worn, resulting in efficiency losses. A solution was required to rebuild the substrate and increase its efficiency.

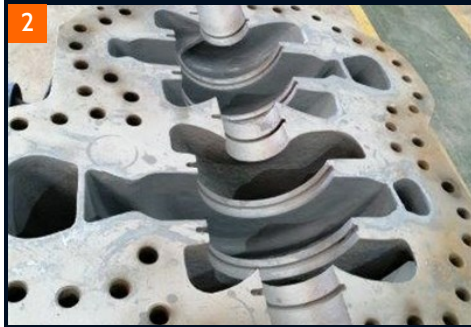
The process fluid had, over time, worn away the existing lining and damaged the substrate.

1. Before Repair
2. After Blasting
3. Rebuilt
4. Finished application
