# BELZONA PROTECTS TANK FROM EXTERNAL CORROSION

ID: 8684

A tank required protection from external corrosion at a food production facility.

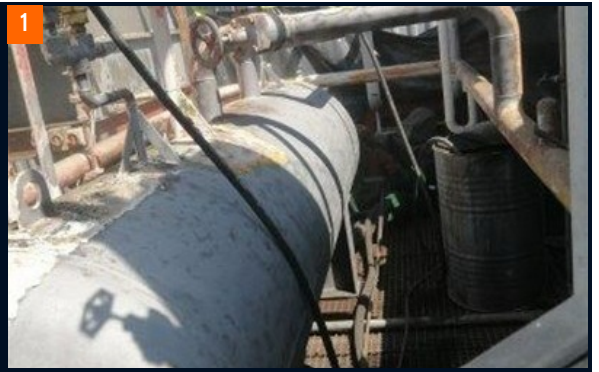
External corrosion and chemical attack of the existing coating

1. Tank prior to surface preparation 2. Tank during surface preparation 3. Tank post surface preparation 4. Completed Application

The surface was grit blasted and Belzona 5811 applied per IFU and system leaflet TCC-03
