# BELZONA RESTORES AND PROTECTS A HYDRO UNIT

ID: 8686

60 year old Kaplan hydro power unit.

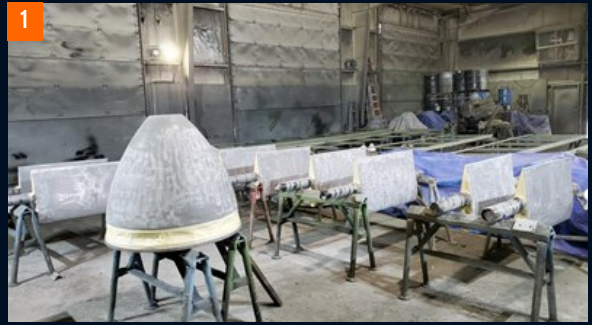
1. Belzona 1111 applied.
2. Belzona 1341 applied.
3. Assembled, and final touch-ups complete.
4. Unit reinstalled.

The parts were all grit blasted and washed with solvent. Belzona 1111 was used to smooth over the wear and cavitation in a full skim coat. Once cured, the Belzona 1111 was sanded down to the required profile, and frost blasted. Two full coats of Belzona 1341 were then applied. As per Belzona system leaflet VPF-01, VPF-02.
