# BELZONA SAVES CAST ALUMINIUM MANDREL

ID: 8699

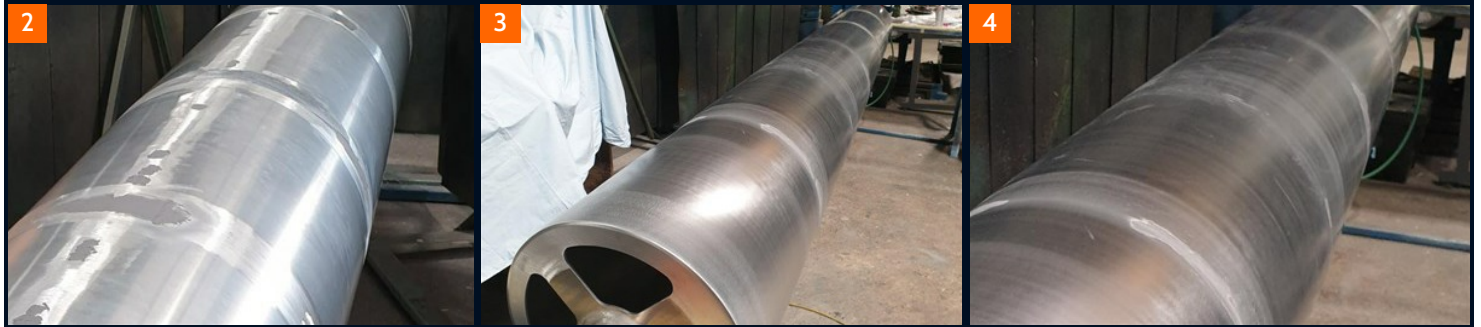
The surface of the mandrel had been compromised and the engineering company's brief was to return the mandrel to a smooth surface finish.

1. Belzona 1511 applied
2. Belzona 1511 applied (close-up)
3. Mandrel repair complete with Belzona 1511 smoothed
4. Close up of completed works

The product was applied in accordance with Belzona System Leaflet MPT-1. After surface preparation, the Belzona 1511 was applied to the surface and smoothed down until it sat flush with the aluminium substrate.

The application was carried out by the engineering company, saving costs against employing an applications contractor. The alternatives would have been aluminium welding and machining. The hot works could have compromised the 4m Mandrel. Using 1kg of Belzona 1511 enabled a swift, cold applied repair and a rapid return to service.
