# SIMPLE OVERHEAD REPAIRS WITH BELZONA 4141

ID: 87

Concrete support columns for electricity supply cables at local sub-station

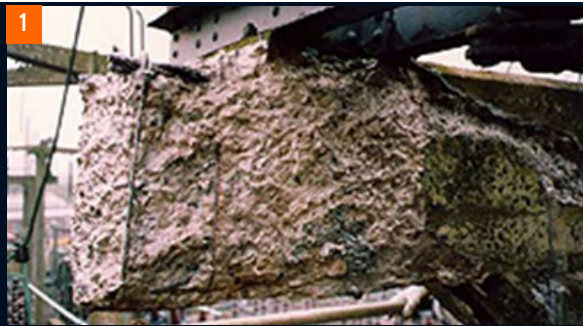
Severe spalling of the concrete accelerated by the acidic atmosphere generated by local industries

1. Close up of the badly spalled concrete
2. Work carried out from simple scaffold platform
3. Close-up of a rebuilt beam prior to application of Belzona 5151

Application was carried out using similar techniques to those detailed in Belzona Know-How leaflet RPA-2. Repairs were finally overcoated with Belzona® 5151 as preventive maintenance on surrounding concrete surfaces.
