# BELZONA CONTAINS SULFURIC ACID

ID: 870

Sulfuric acid leaks were eroding concrete pump bases as well as floor in small containment area

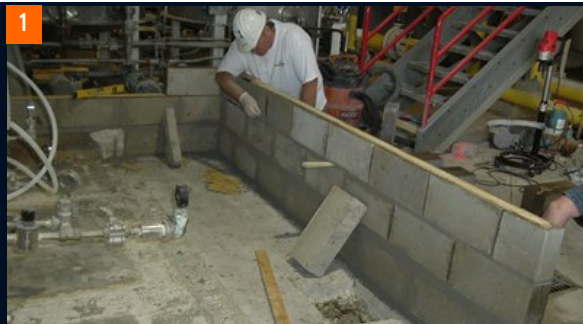
1. Concrete block being laid with Belzona 4131 as mortar
2. Floor sloped to the drain
3. Pumps back in service
4. Completed drain

Application was carried out in accordance with modified Belzona System Leaflets TCC-9 & 15. Concrete blocks were laid using Belzona® 4131 as mortar. Floor was re-profiled and sloped so any spill would run towards the drain. The entire floor and walls were coated with Belzona® 4311.
