# BELZONA REBUILDS & PROTECTS BEET WASHERS

ID: 8700

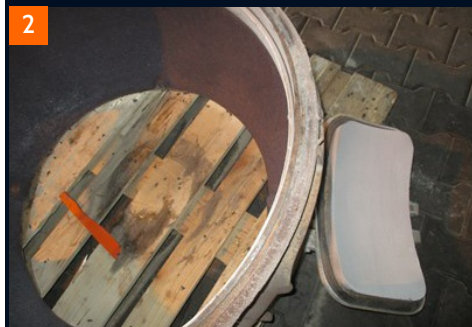
Due to the demanding nature of the sugar beet washers operation - humidity, abrasion and erosion - leading to accelerated rates of corrosion and wear resulting in through wall defects due to repeated abrasion and erosion from the sugar beet during operation.

- 1). Deteriated Beet Washers in Situ,
- 2). Partial Belzona 1812 coated Wash Bowl,
- 3). Partial Belzona 1812 coated Lid,
- 4). Top Coated Lid using Belzona 1321

The wash bowl and top lid, were grit blasted prior to being rebuilt to their original profile using Belzona 1111. This was followed by the application of Belzona 1812 which has ceramic fillers inside to reduce and combat the abrasive wear, providing resistance to fine particle abrasion in particular. The bowl and lid were then coated using Belzona 1321 to provide a smoother surface on top of the sacrificial lining. The application was carried out in accordance with Belzona System Leaflet GSS-5 & GSS-9.
