# RESTORATION OF TURBINE STAY RING AND VANES WITH BELZONA

ID: 8705

Repair of the stay rings and draft tube of a 140Mw turbine operating within a hydroelectric power plant.

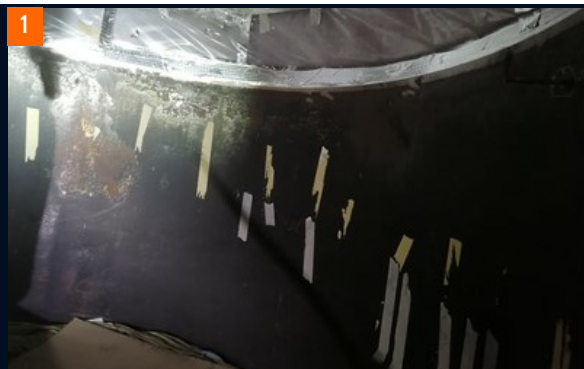
After 10 years of operation, the stay ring and vanes had lost thickness due to erosion. During a routine inspection, the surfaces had also been identified as being rough, resulting in a loss of efficiency and an increase in power consumption. The cause of roughness on the stay ring and vanes was because of foreign matter (sand, silt, mud etc.) within the process.

- 1.) Damaged stay ring prior to application
- 2.) The fixed wings before the application
- 3.) The stay ring after the application
- 4.) Final application - Belzona 1341 + Belzona 2141

This application was carried out in accordance with modified system leaflets CEP-01, CEP-05 & CEP-10.  
First, the turbine was grit blasted to SA2.5, achieving a surface profile of 75 microns before being cleaned with Belzona 9111. Once the surface was clean & dry, the pitted stay ring, vanes and draft tube were rebuilt with Belzona 1311, restoring the equipment back to its original dimensions. After the Belzona 1311 had cured, the surface was frost blasted (40 microns) before applying Belzona 1321 to the draft tube and Belzona 1341 to stay ring and vanes. Finally Belzona 2941 & Belzona 2141 were applied to the tips of the stay vanes for their anti-cavitation properties.
