# BELZONA REPAIRS AND PROTECTS DRAFT TUBE

ID: 8707

Rebuild and repair of a draft tube used as part of a Hydroelectric process.

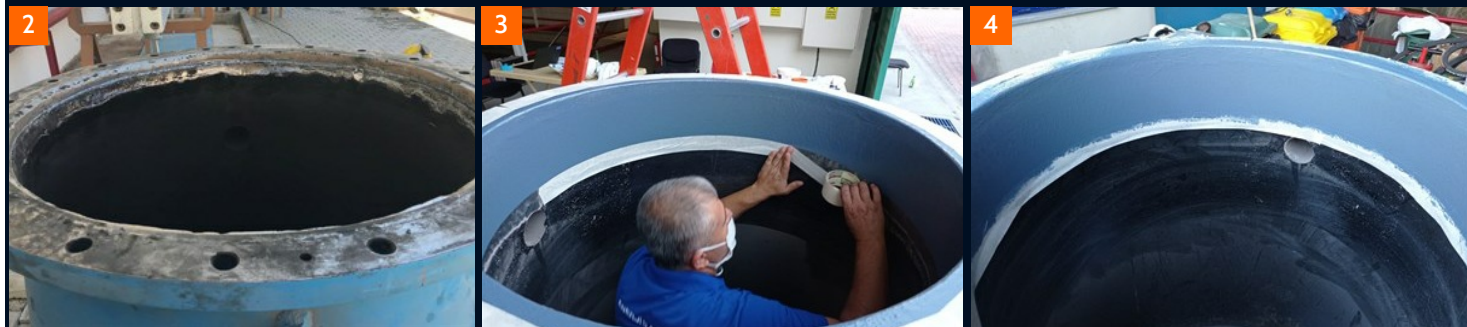
Corrosion and cavitation on the draft tube caused by pressure fluctuations.

- 1.) Surface loss caused by corrosion and cavitation
- 2.) After mechanical cleaning
- 3.) Preparation for the application of the second layer of Belzona 1321
- 4.) Coated with Belzona 1321 in two layers

This application was carried out in accordance with a modified version of system leaflet VPF-01. After the surface preparation, Belzona 1311 was used to resurface the profile. Once the damaged areas had been repaired, the 40 cm inner part of the draft tube where cavitation was intense, was coated with Belzona 1321 in order to provide cavitation and erosion resistance.
