# BELZONA PROTECTS HOT WATER TANKS

ID: 871

Severe internal corrosion

Hot water generation tanks within the Powerhouse.

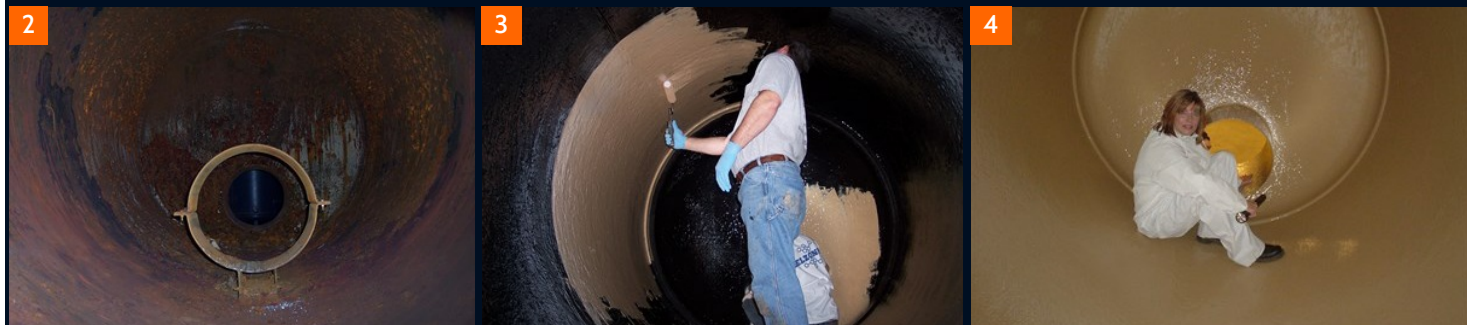
## PHOTOS

1. The tank inside the Powerhouse
2. View of the internal corrosion
3. Contractor applying 2nd coat of Belzona 5811
4. Technical Consultant inside the finished tank 2 days later

Application was carried out in accordance with Belzona Know-How System Leaflet TCC-5.

Belzona 5811 (Immersion Grade)  
Belzona 1111 (Super Metal)
