# BELZONA REPAIR TO POWER PLANT COAL BELT

ID: 874

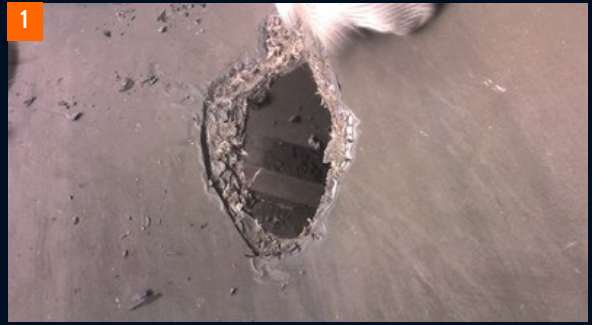
Belt developed a large burn hole. This rendered the belt unusable until fixed.

1. Hole in the belt being prepared
2. Preparation completed
3. Completed application
4. Completed application

Belt was repaired according to Belzona System Laflet SHM-1
