# BELZONA PUMP COATING OFFERS A SAVING OF UP TO 20% ON ENERGY COSTS

ID: 8752

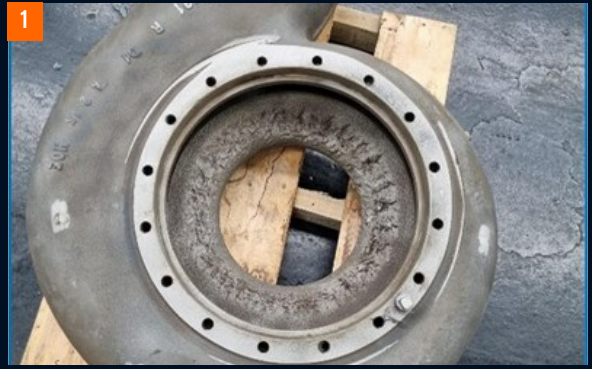
The pump casing had corrosion and erosion damage around the surface area where the open impeller vane tip runs. One of the pumps had its performance analysed on a test rig. The hydraulic efficiency was found to be down at 38.3%.

1. Pump casing with corrosion and erosion damage
2. Erosion repaired using Belzona 1111
3. Re-profiled volute casing and first coat of Belzona 1341 applied
4. Belzona 1341 applied to all the pump volute internal water ways
