# INTERNAL JOINT REPAIR TO STAINLESS STEEL PASTEURISER AT A BREWERY

ID: 8753

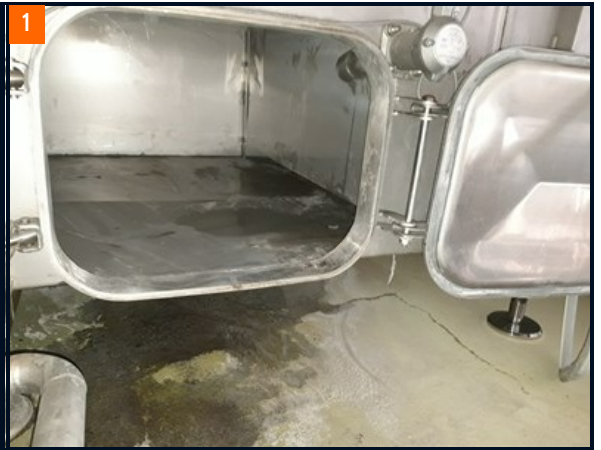
A stainless steel pasteurising bottling line had a large leak from a joint. The pasteurizer could not be disassembled to replace the gasket and therefore the only option was to seal the joint in situ.

The internal seal between two sections of the stainless steel pasteurising bottling line had developed a leak.

1. Leaking pasteuriser 2. Surface of the seam prepared prior to repair 3. Belzona 1511 used to bond plates in place 4. Completed repair
