# BELZONA REPAIRS CHEMICAL STORAGE ROOM FLOOR

ID: 8754

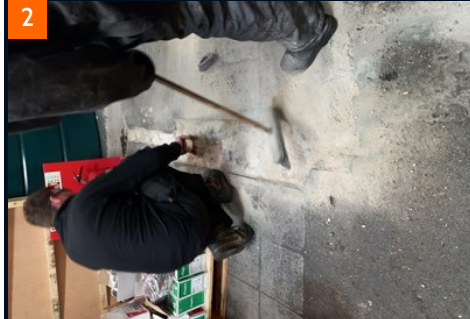
Steel tiles had failed in one area of a chemical storage area, leaving damaged concrete. Any repairs needed to be able to protect against water and general chemical use.

A floor area in a chemical storage room had become worn over time due to both mechanical and chemical attack.

1. Target area identified for training purposes
2. Cleaning out the loose and friable materials
3. Belzona 4911 Conditioner mixed and applied
4. Belzona 4131 laid, compressed and smoothed to finish

All loose and friable materials were removed from the target area, using a wire brush, soft brush and compressed air. The area was conditioned using Belzona 4911 (TX-Conditioner). Following the conditioning, Belzona 4131 was applied, and were finished level with the rest of the floor.
