# APPLE CIDERY LOADING BAY COATED WITH BELZONA

ID: 8756

Renovation of a loading bay at an Apple Cidery.

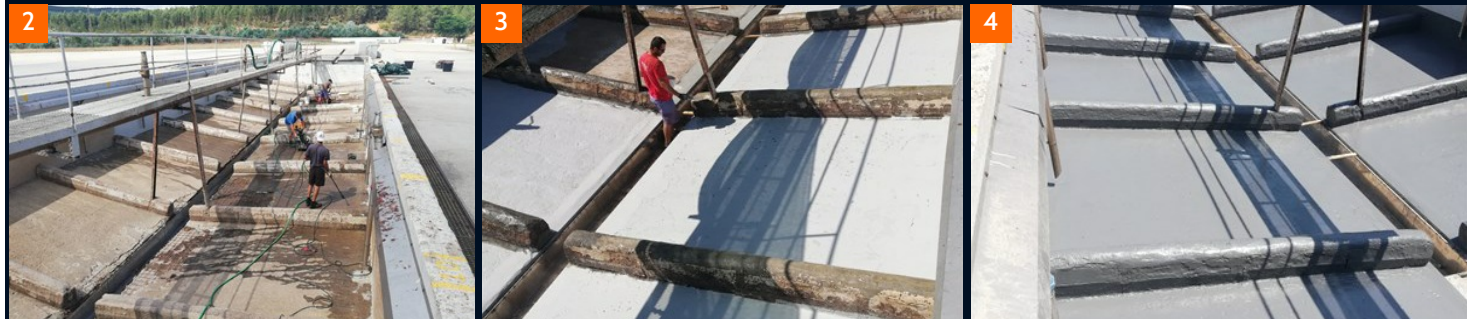
Lorries would arrive on site and dump apples into the loading bay. The juices from the apples were acidic, and over time started to degrade the concrete bay and chemical channel flowing through the bay

- 1.) Loading bay prior to application
- 2.) Surface preparation - Concrete scarifier + UHP
- 3.) Chemical channel rebuilt with Belzona 4111 + 1st coat of Belzona 5231 being applied
- 4.) Finished application - 2 coats of Belzona 5231 applied

This application was carried out in accordance with system leaflet FPA-03. The first step was to remove and depose of any loose concrete. Once the bulk of the loose concrete had been removed, a concrete scarifier was used to roughen up the substrate before being pressure washed down using UHP (Ultra-High Pressure) water jetting. Once the concrete was prepared, Belzona 4111 was used to rebuild the edges of the chemical drain before 2 coat of Belzona 5231 were applied to the whole bay (270m<sup>2</sup>).
