# SUMP REPAIR & COATING WORKS

ID: 8762

A sump within a whiskey distillery required repair and coating to improve the cleanliness & aesthetics of the area.

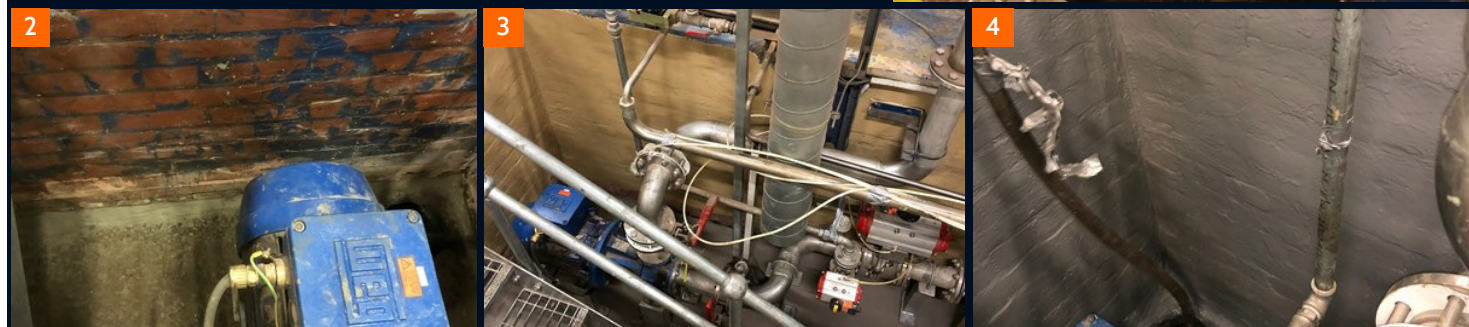
The sump had deteriorated through spillages & nearby leaks. Limited downtime was available for these works as they were to be carried out during a shutdown.

- 1) Sump before
- 2) Surface preparation complete & Belzona 4131 installed
- 3) Belzona 4131 applied to the floor & Belzona 5811 first coat applied to the walls
- 4) 2nd coat of Belzona 5811 applied

The floor & walls were power washed & mechanically prepared with floor grinders. The full floor surface was then repaired with Belzona 4131 to provide a level, hard wearing surface. Fillets were also installed around the perimeter. Following this two coats of Belzona 5811 were applied to the floor & walls.
