# BELZONA 5711 / 5721 MAKES SUCCESSFUL DEBUT IN THAILAND

ID: 8767

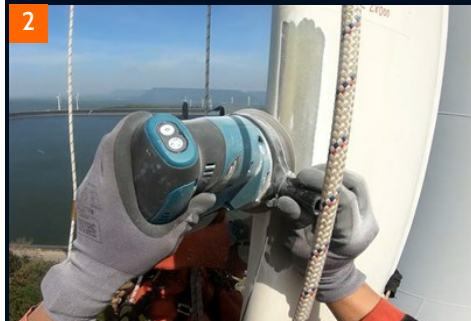
Photo 2 - Surface Preparation

Before travelling to the project site, the application team completed a one-day course on how to repair wind turbine blades using Belzona 5711/5721 at the Belzona Training Facility in Thailand. Onsite, a three-person team, two applicators using rope access, and one spotter on the ground carried out the application. Each damaged blade was cleaned using water and a degreaser, and the affected area was identified and marked. The damaged surfaces were sanded down with 80 grit sandpaper, and Belzona 5711 was applied with an applicator and rubber strap to repair the physical damage on the blades. After the Belzona 5711 product had cured, the area was sanded once again to provide a smooth finish; masking tape was then used to mark out the areas for coating. Belzona 5721 was then applied within the Belzona 5711 overcoating window to the affected areas with a brush. After completing the applications, the masking tape was removed, and the WTG unit was ready to return to service.

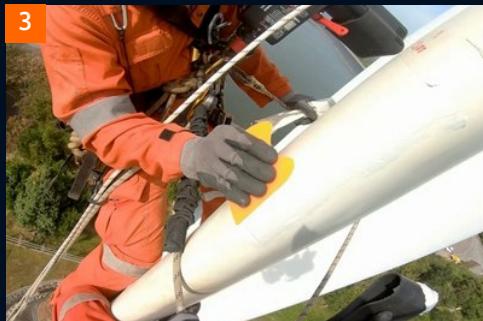
Photo 3 - Applying Belzona 5711

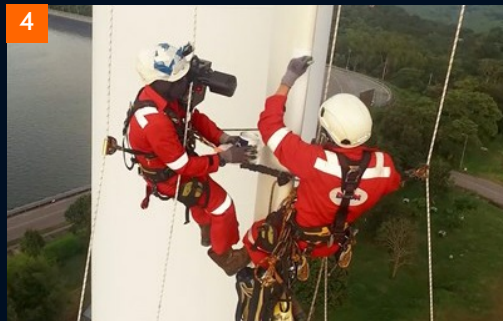
Photo 4 - Applying Belzona 5721
