# BELZONA PROTECTS A LEADING EDGE OF A WIND TURBINE BLADE

ID: 8769

Leading edge of a wind turbine blade.

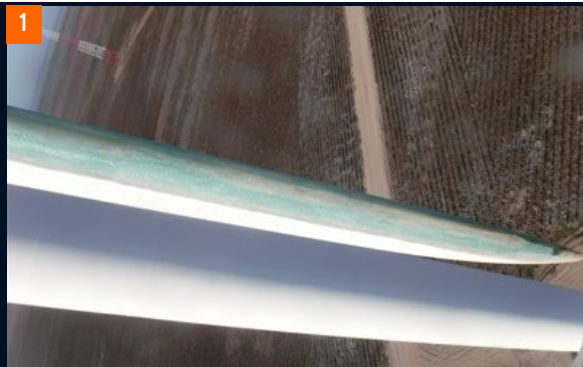
Leading Edge Erosion (LEE). The effects of raindrops, sand and hail chewed-up the leading edge on the rotating blades. If not repaired, LEE can leave the blades unbalanced, affecting the shaft and gearbox resulting in energy loss.

1. Gel coat removed.
2. The blade fully prepped.
3. Finished application with Belzona 5721 in white.

The application was carried out in accordance with the Belzona System Leaflet FBC-16 and Belzona 5721 "Instructions For Use". First the surface was rebuilt using Belzona 1221. 2911 conditioner was applied to the coating area to have optimum adhesion. Then the surface was overcoated with one coat of Belzona 5721 - LEP coating.
