# LARGE HOLE IN TANK REPAIRED WITH BELZONA

ID: 877

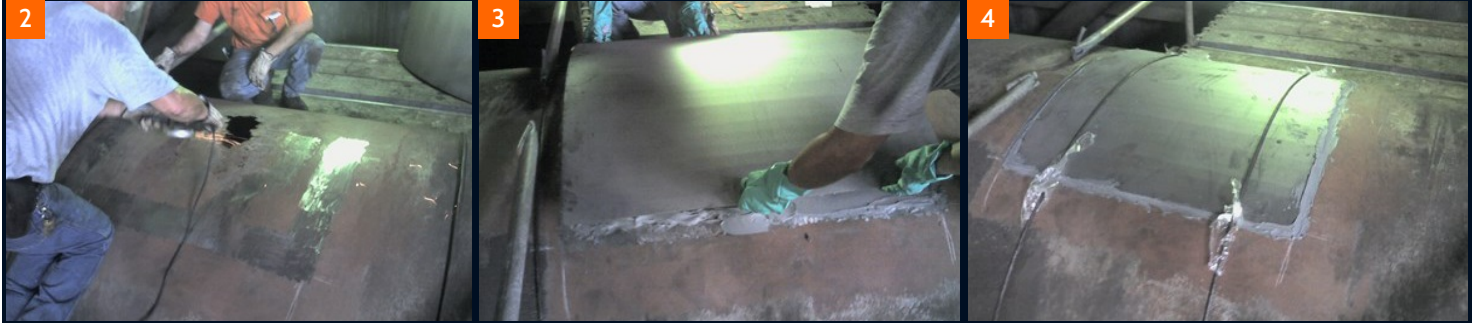
The tank developed a large hole in the top due to years of corrosion

1. General view of the tank
2. Surface preparation underway
3. Doubler plate being positioned and bonded in place
4. Completed repair

Tank was repaired in accordance with Belzona Know-How System Leaflet TCC-1. Doubler plate was bonded over the holed area.
