# BELZONA PROTECTS SWITCH GEAR BOXES AT A WIND FARM

ID: 8770

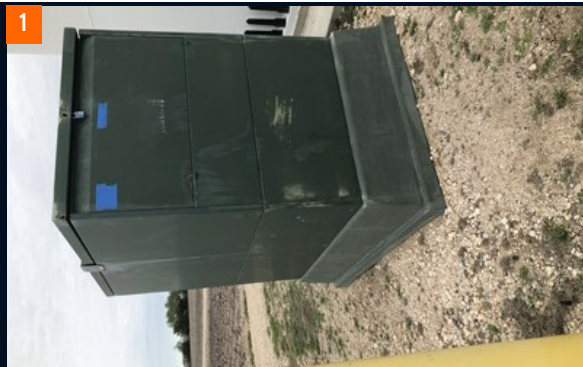
Damage on the metallic surface caused by corrosion from the salt environment. If neglected, wall thickness deteriorates and the asset integrity becomes compromised.

1. The surface is cleaned and manually prepared.
2. Belzona 3921 Conditioner is applied.
3. Belzona 5111 is applied and the applications is complete.

The location of the switch gear boxes made it easy to prep and apply coatings. Abrasive blasting was not allowed. Orbital sanders were used to acquire a surface provided required to apply coatings. First, the Switch Gear Boxes were coated with Belzona 3921 Conditioner that is zinc rich and also acts as a corrosion inhibitor. Then, Belzona 5111 was then applied for the finish UV protection and final environmental protection. The application was carried out in accordance with the Belzona System Leaflet CEP-4 and Instructions for Use.
