# BELZONA REPAIRS AND PROTECTS WIND TURBINE COLUMNS

ID: 8771

Wind turbine columns.

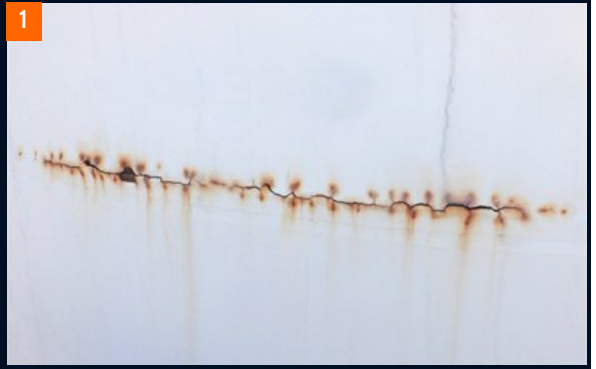
Damage on the surface of the columns caused by salt deposits from rain and fog settlements. Elements create corrosive areas on equipment and metallic columns are no exception. The Customer felt if the issue was not addressed in due time, through-wall defects could lead to a loss of structural integrity, which could pose a bigger issue long-term.

1. Showing damage.
2. The area is prepped using an MBX Bristle Blaster, and masked off for the application.
3. Belzona 1331 is applied and the application is complete.
