# BELZONA 4301 REBUILDS AN ACID INTAKE NOZZLE

ID: 8772

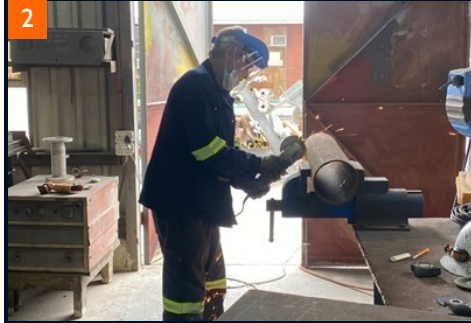
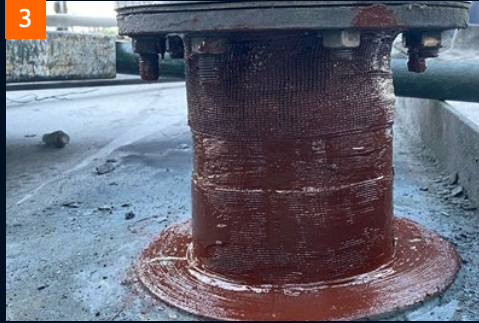
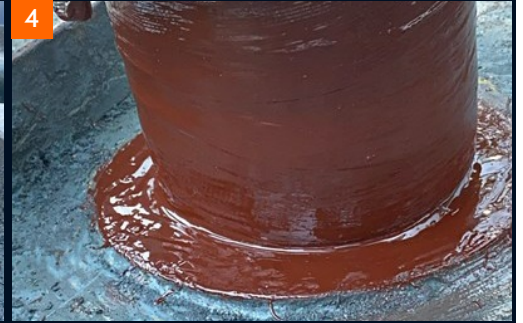
The acid used in the process had severely damaged steel, affecting its structural integrity

An acid intake nozzle was severely compromised, requiring an urgent repair.

- 1 - Initial condition
- 2- Surface Preparation
- 3 - Belzona 4301 Application
- 4 - Belzona 4301 Application

Applied in accordance with Belzona system leaflet VPF-08

Belzona 4301 offers a chemical resistant rebuild material which could resist the acids present in the process.
