# WIND TURBINE BEDFRAME REPAIRED WITH BELZONA

ID: 8776

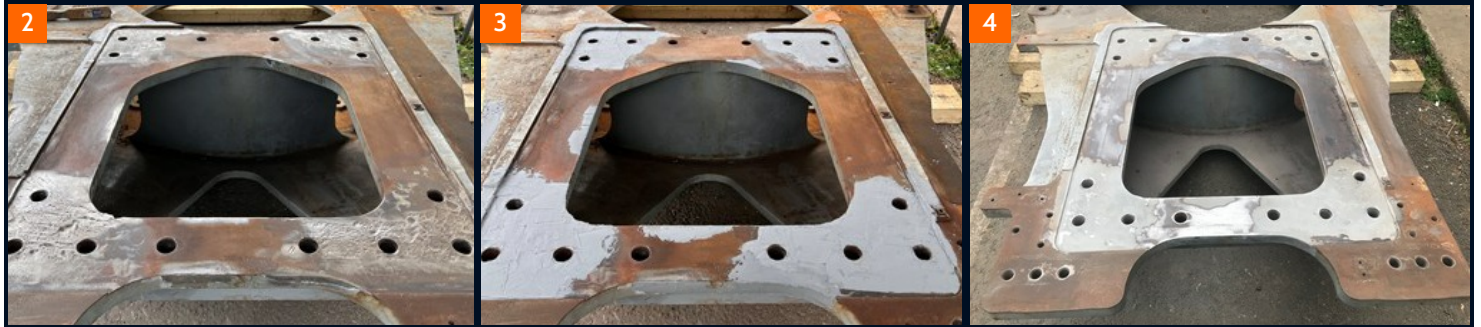
A wind turbine nacelle bedframe had become damaged through corrosion. The corrosion had formed pitted areas where the main shaft pedesal is landed. A flat surface was required to bolt onto with no gaps where water could ingress & cause future corrosion.

1. Metal loss shown on the casing
2. Power tool preparation on the damaged surfaces
3. Belzona 1111 built up proud of casing
4. The Belzona 1111 machined flat with the surrounding metal

The application was carried out in accordance with Belzona System Leaflet GSS-06. The area was first prepared with an angle grinder & MBX Bristle Blaster. The Belzona 1111 Supermetal was then applied proud of the surrounding metal. Once it reached its initial cure stage it was then sanded down flat with the undamaged sections of the casing.

The Belzona repair was carried out without the risk of distortion of the casing. Once cured the product has a very high compressive strength, it also does not corrode in normal conditions so it will prevent future corrosion if water does reach the area.
