# TANK BASE SEALING WITH BELZONA SOLUTION

Large oil tank

Coal Fired Power Plant, Missouri

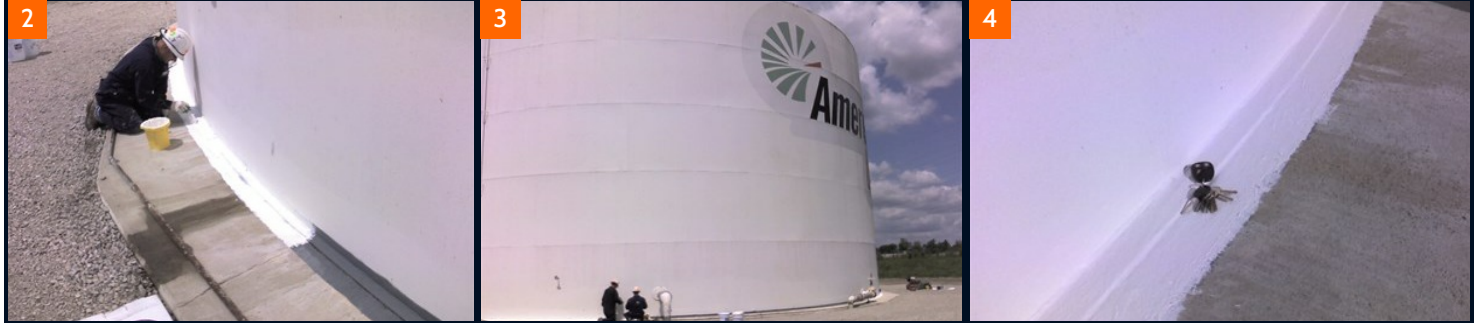
Moisture was seeping through the concrete tank pad and collecting under the tank. Plant officials feared that the tank bottom would be compromised by subsequent corrosion.

1. Chime angle before application
2. Application underway
3. View of tank size
4. Completed Application

Other products had failed to seal the chime angle. Plant engineers were needing a reliable product that would adhere to both substrates. Belzona was chosen for its ease of application and excellent reputation. The application was completed quickly and effectively.

Belzona 3111 (Flexible Membrane)
