# BELZONA REBUILDS GRUNDFOS PUMP IMPELLER FOR THE WASTEWATER INDUSTRY

ID: 8785

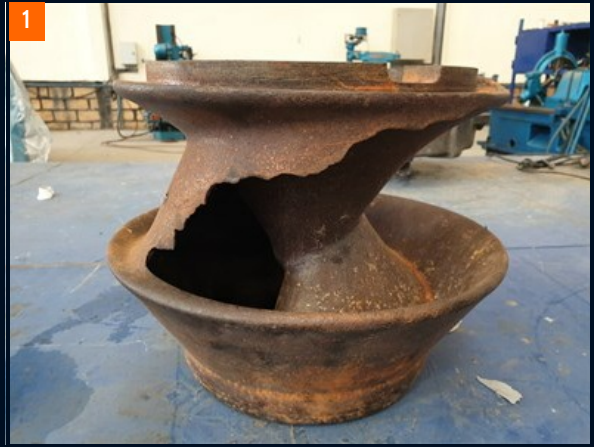
A Grundfos pump impeller had been severely damaged during normal service by erosion and corrosion.

1). Damaged pump impeller. 2). Pump impeller with leading edge armament. 3). Leading edge rebuilt using Belzona 1311. 4). Completed application with final coat of BZ1321.
