# BELZONA PROTECTS AN ALSTOM SEAWATER PUMP VALVE

ID: 8786

Sea pump valve at a Thermal Power Plant.

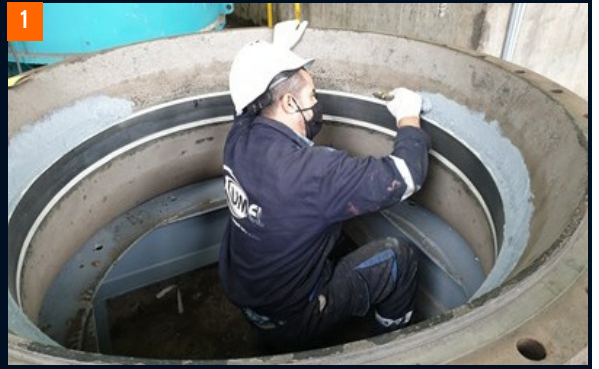
1). Belzona 1111 pushed into the surface profile with a bristle brush. 2). Belzona 1111 & Belzona 9341 reinforcement sheet is added to provide strength. 3). Completed Belzona 1311 rebuild repair. 4). Completed application overcoated with Belzona 1321.

The valve was rebuilt on the inside using Belzona 1111 and then reinforced using Belzona 9341 before being overcoated using Belzona 1321. The application was carried out in accordance with Belzona System Leaflet PDP-05.
