# BELZONA PROTECTS INLET SPOOLS OF AN ALSTOM SEAWATER PUMP

ID: 8787

Inlet spool of a sea pump at a Thermal Power Plant.

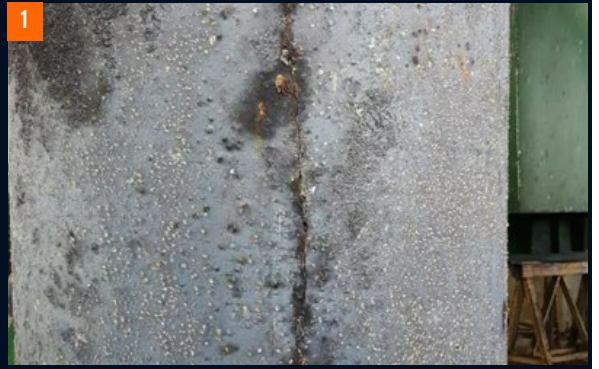
The inlet spool of an Alstom sea pump was cracked (1500mm along the length of the spool) on the outside and suffered corrosion due to sea water, therefore needing to be repaired and protected against future wear along with other parts of the pump.

1). Original condition of the Inlet Spool. 2). Surface preparation, termination and V-ing out of the 1500mm crack. 3). Reloading of the inlet spool crack and partial coating application. 4). Completed application overcoated with Belzona 1321.
