# BELZONA BRINGS NEW LIFE TO AN ALSTOM SEA PUMP TURBINE

ID: 8788

Alstom sea pump turbine at a Thermal Power Plant.

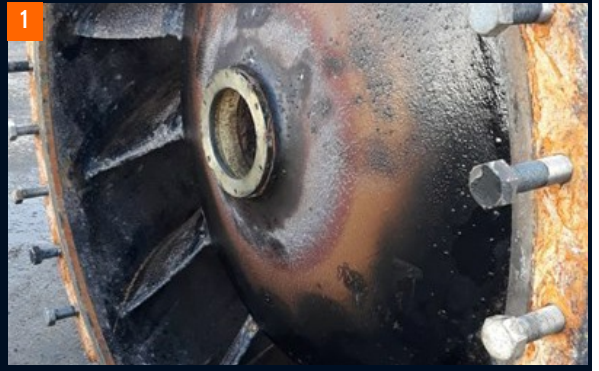
The leading edges of the vanes were severely damaged due to erosion and corrosion, along with the bearing housing of the turbine.

- 1). Original damaged state of the turbine.
- 2). Rebuilding of the leading edge on the vanes.
- 3). Rebalancing of the Turbine.
- 4). Completed application of the Turbine.
