# SEAWATER PUMP GETS THE FULL BELZONA SERVICE

ID: 8789

Seawater pump at a Sulphur & Phosphate processing plant.

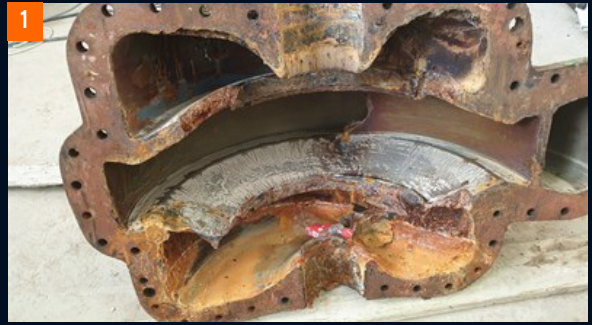
The Kirloskar seawater pump was suffering from general corrosion and bi-metallic corrosion (galvanic corrosion) on the wear rings.

- 1). Original condition of the seawater pump casing.
- 2). Wear rings and cutwaters being rebuilt using Belzona 1111.
- 3). Pump impeller rebuilt and protected.
- 4). Completed seawater pump application.

The seawater pump was grit-blasted, the cutwaters and wear rings were then rebuilt to their original OEM profile using Belzona 1111 before being overcoated with Belzona 1321. The pump impeller was also rebuilt and protected against corrosion. The application was carried out in accordance with Belzona System Leaflet CEP-01 & CEP-02.
