# EXPANSION JOINT AT HOSPITAL SEALED WITH BELZONA

Expansion joints in the hospital had become a tripping hazard

Hospital, Missouri

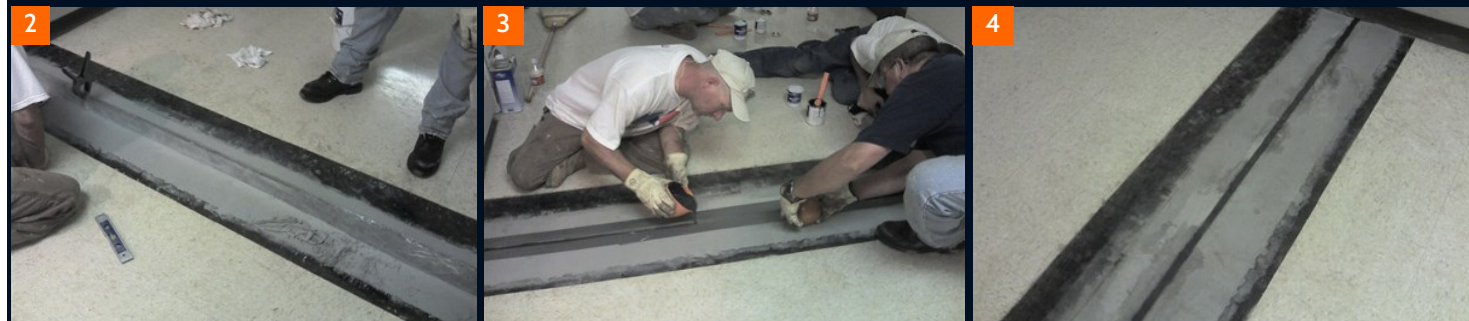
Expansion joints in corridor in need of repair

1. View of joint with kick plate removed
2. Application of Belzona 4111
3. Application of Belzona 2221
4. Completed application

Application was carried out in accordance with Belzona Know-How System Leaflets FPA-5 and -6.

Belzona 4111 (Magma Quartz) Belzona 2221 (MP Fluid Elastomer)
