# BELZONA REPAIRS SCHOOLS CHILLER

ID: 880

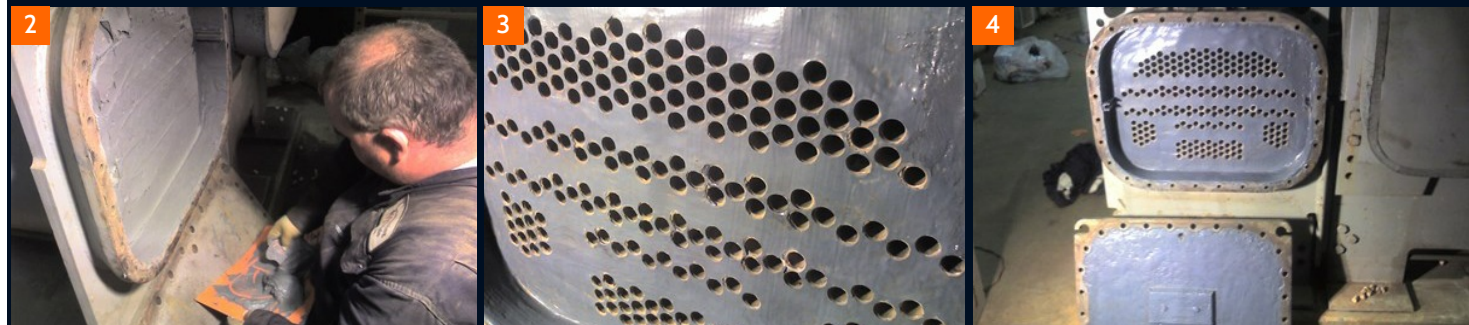
## PHOTOS

Years of service had caused extensive corrosion on the chiller tube sheet face.

Corroded chiller face

1. Corroded tube sheet face
2. Application in progress
3. Completed application
4. Completed application

Application was completed in accordance with Belzona System Leaflet HEX-1.

Belzona 1311 (Ceramic R-Metal)  
Belzona 1321 (Ceramic S-Metal)
