# PIPE REPAIR AT A PUMP STATION

ID: 8800

## PROBLEM

Heavy corrosion of the internal of the pipes needed repairing to ensure protection of dyke.

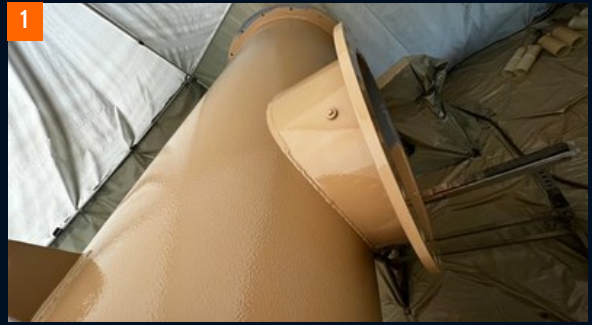
Image 1: First Layer of Belzona 5811

The heavy corroded areas were filled and smoothed with Belzona 1111. Belzona 5811 was used to coat the internal and external of the pipe for further corrosion protection.

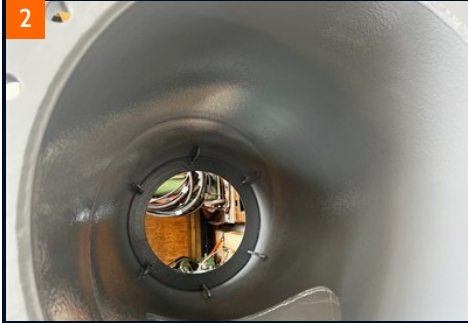
Image 2: Second Layer of Belzona 5811

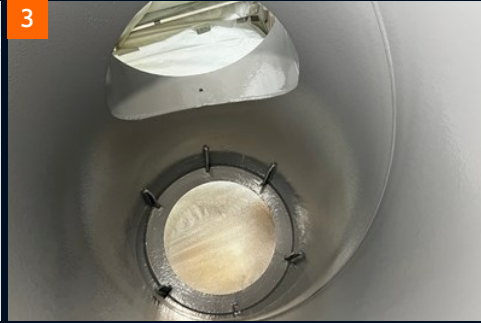
Image 3: Internal Application Complete

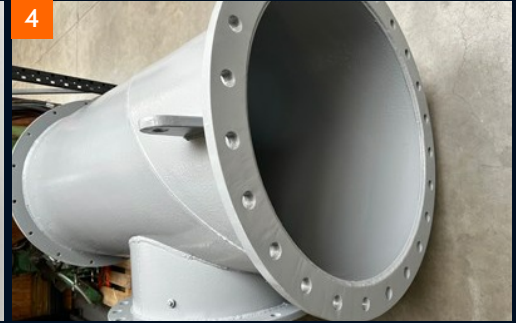
Image 4: External Application Complete
