# BELZONA REPAIRS AND PROTECTS MACHINE TOOL COOLANT TANK

ID: 884

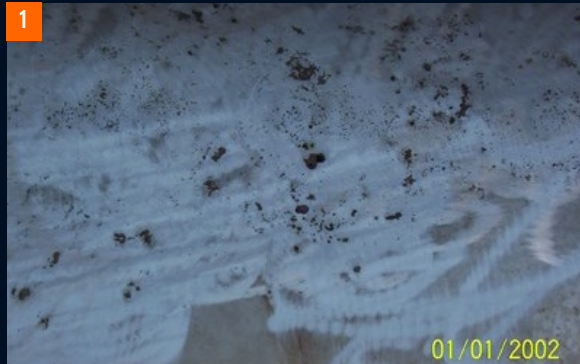
The cutting fluid is water based. The tanks rust because the cutting fluid and the cuttings sit on the bottom of the tank. The tanks leak and cause a big mess and safety hazard.

1. Typical rust holes
2. Blast cleaned tank
3. Totally sealed tank
